City of Poway

Hazardous Tree Removal Project

Along Espola Road

MARCH 4, 2022

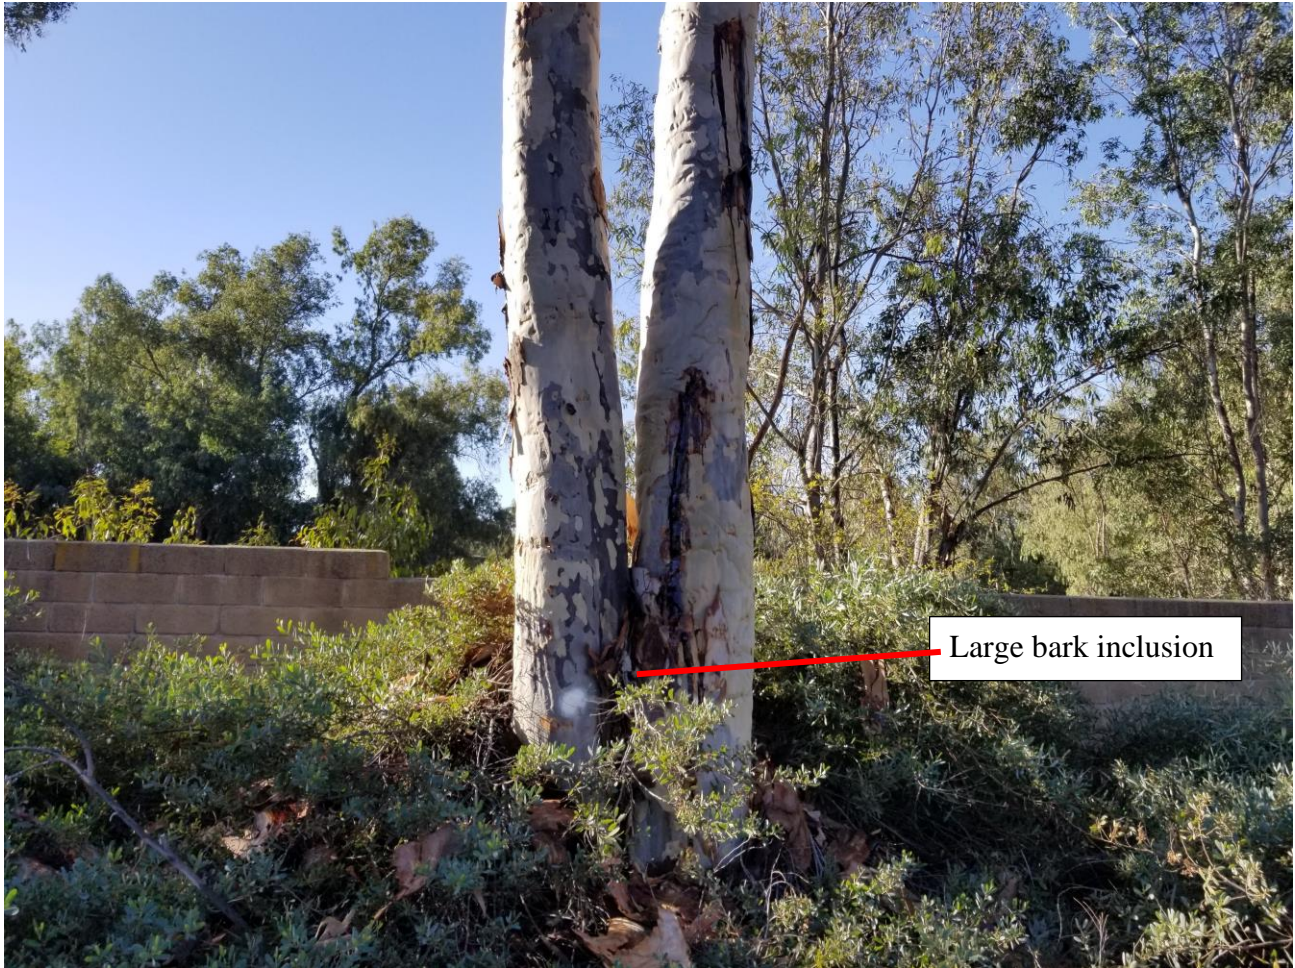
Photo #6

- Shown above is an example of a tree marked for removal due to its poor structure.

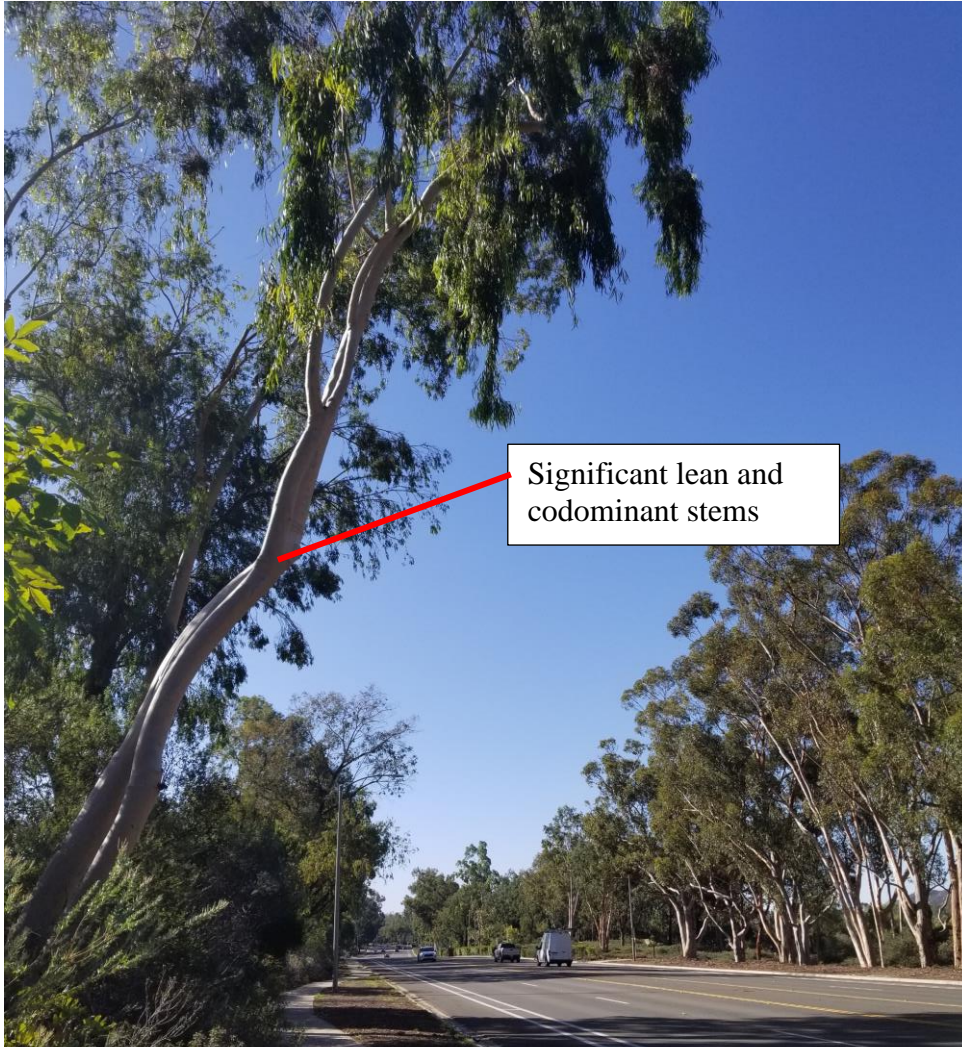
Photo #7

- Shown above is an example of another tree marked for removal due to poor structure.

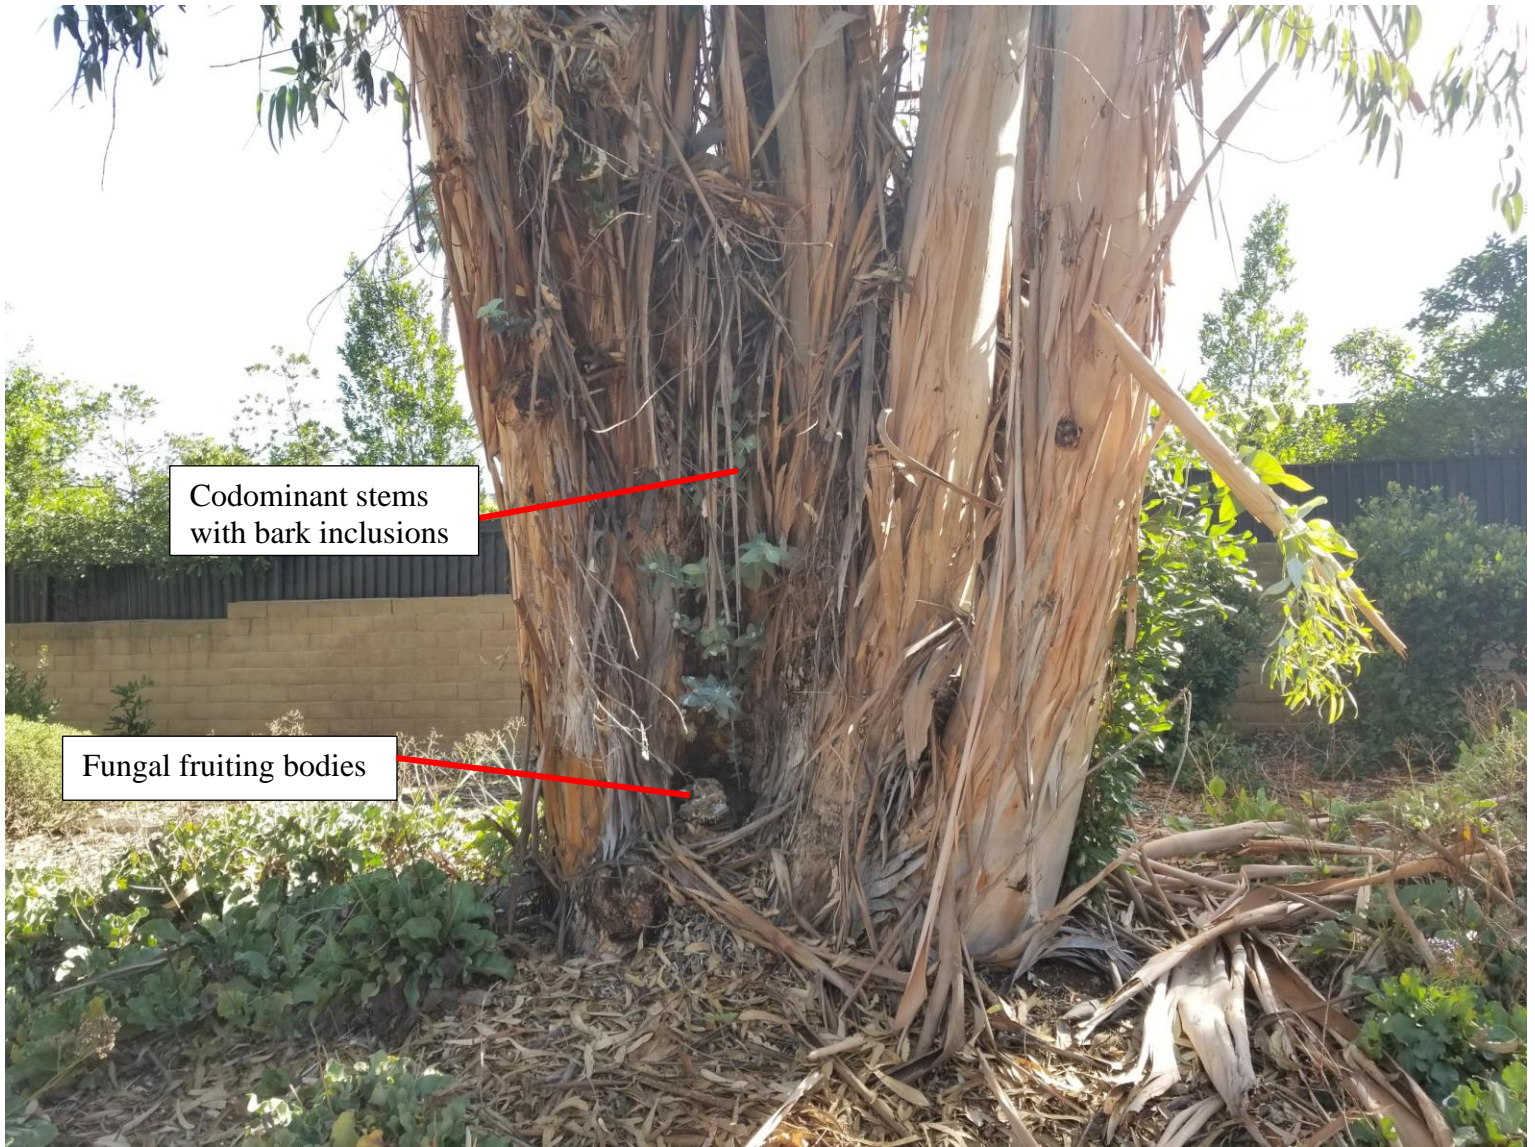
Photo #8

- Shown above is an example of another tree marked for removal due to poor structure.

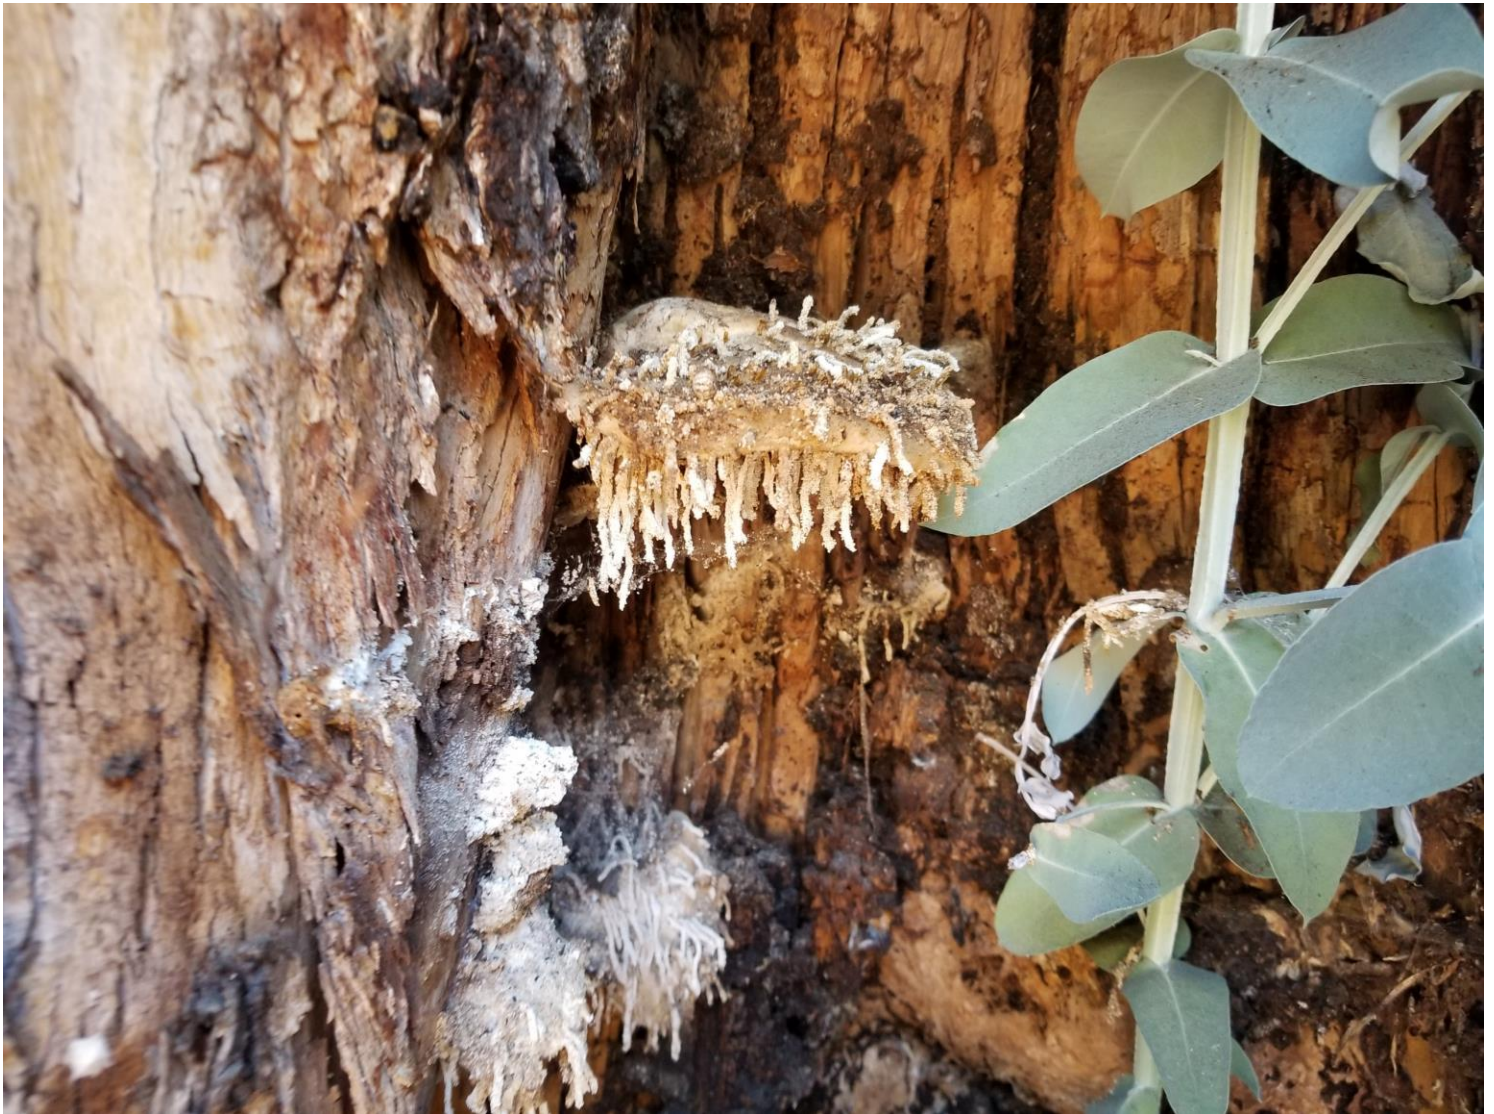
Photo #9

- Shown above is a close up of the fungal fruiting bodies in the previous photo. These *Laetiporus gilbertsonii* conks reduce wood elasticity and increase the likelihood of failures.

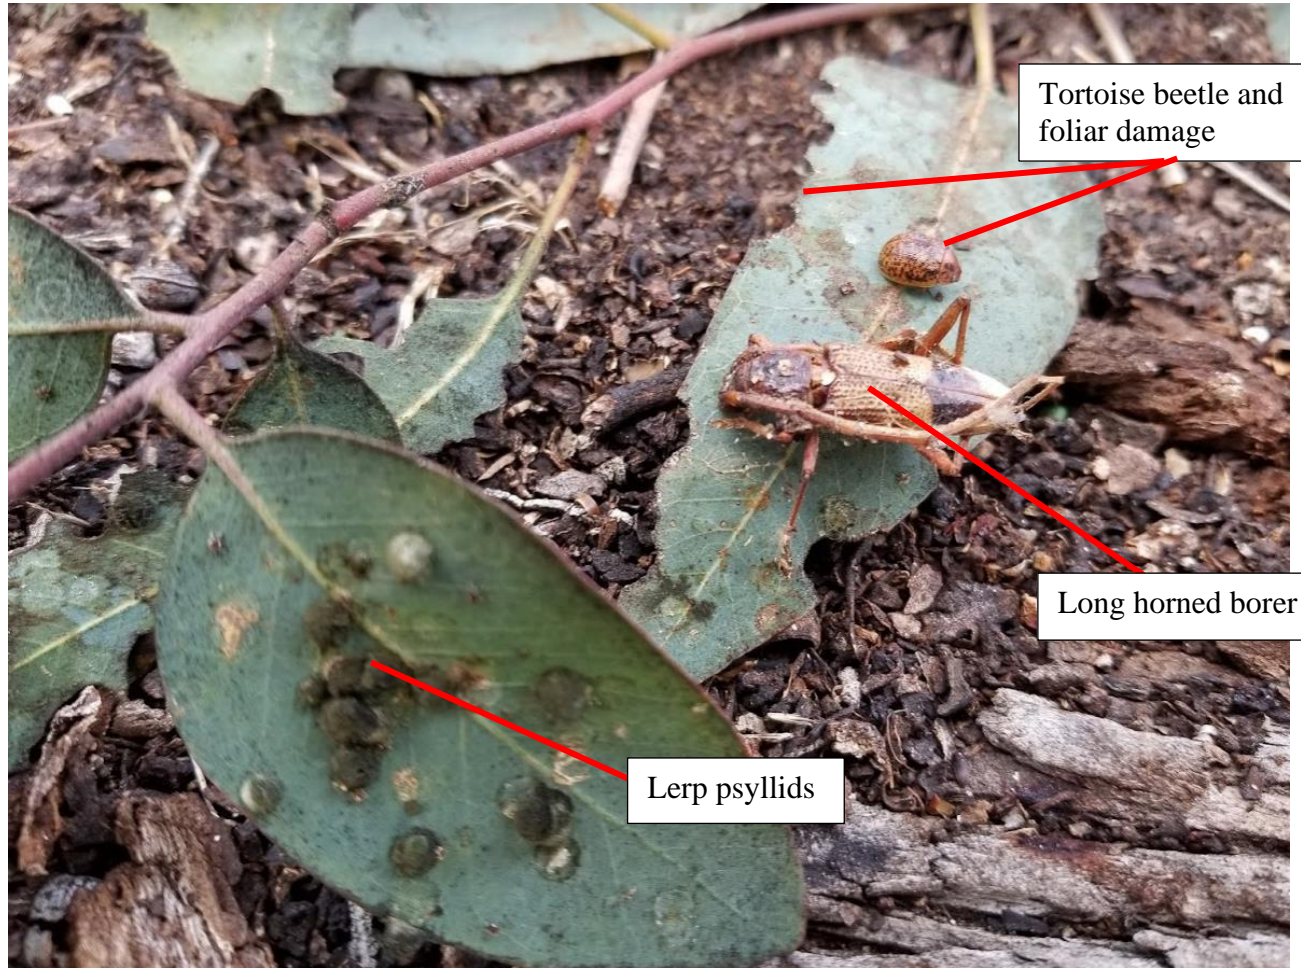
Photo #10

Tree health was generally fair (50% of trees); 14 trees were dead, and 18 were diseased or declining trees showing symptoms of drought stress and pests such as long-horned borers, lerp psyllids, and tortoise beetles. These pests tend to target stressed trees; the primary health recommendation would be to improve the growing environment by topdressing with 3-4 inches of coarse organic mulch over bare soil and to provide deep irregular irrigation to the entire planting area. WCA can also offer treatment options with insecticides or plant growth regulators to help manage pest populations and reduce stress.

- Shown above is an example of tree pests observed in the area.

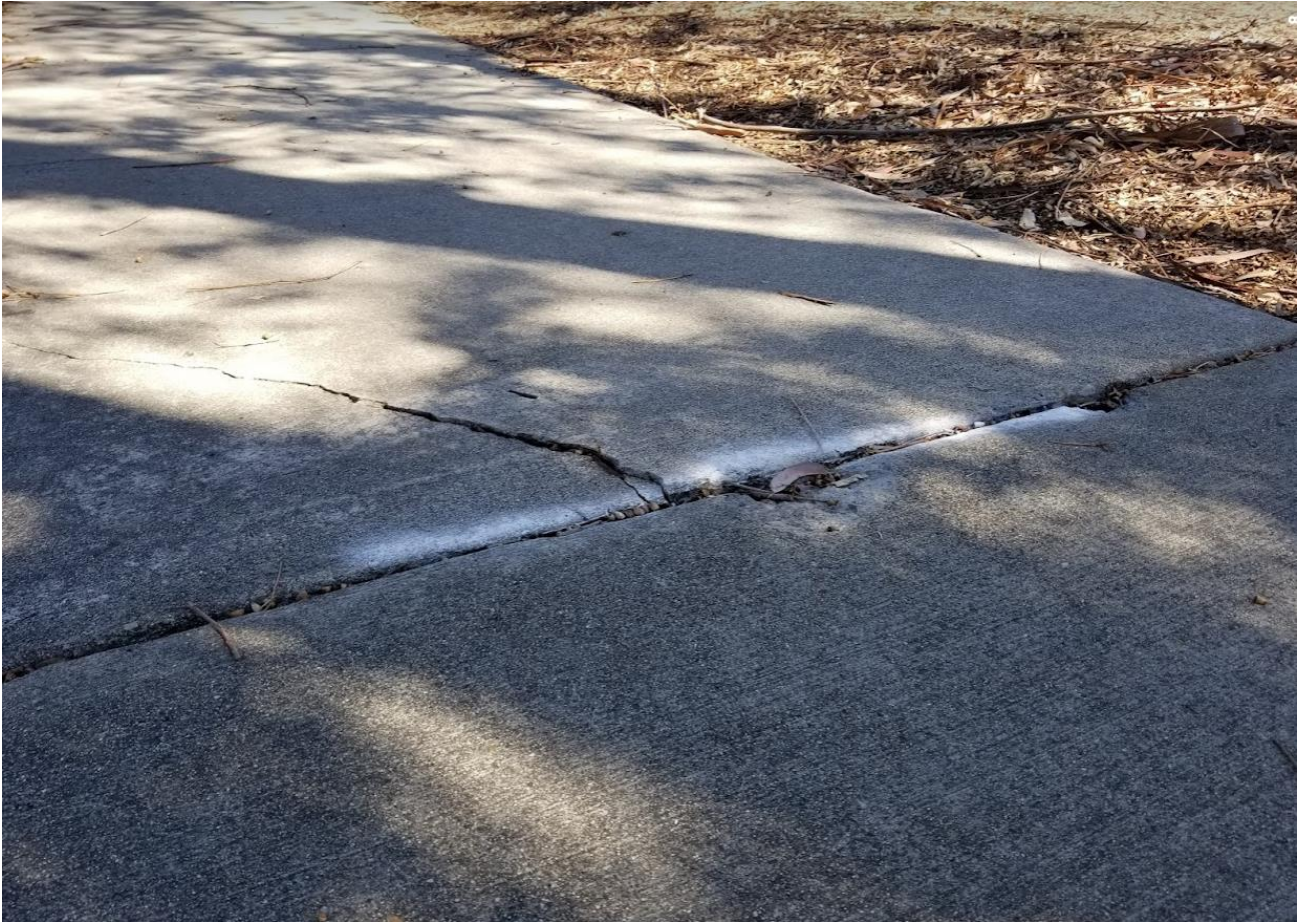
Photo #11

- Shown above is an example of a sidewalk deflection, several trees were marked for removal due to root conflicts with hardscaping.
